Tech Tip

December 2024

Link Low Superheat Alert

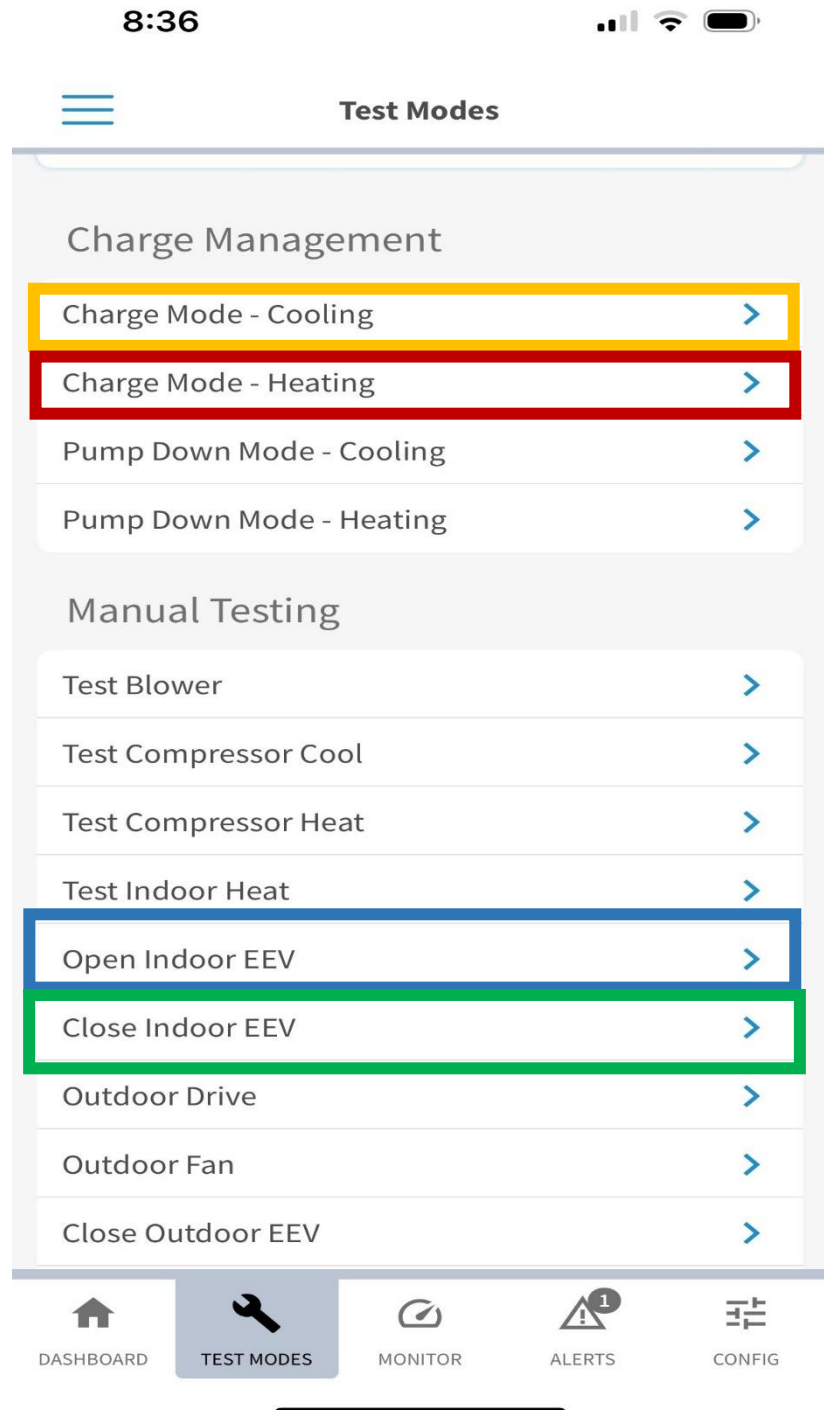
Link System will report multiple low Superheat alerts on the indoor EEV. There are 5 steps in clearing this error up.

1. Make sure Hub has been updated to 8.01 software or higher.
2. Using the tech app (shown to the right) or the UX360 put the unit in charge mode cooling for 5 minutes.
3. Do indoor EEV test open
4. Do indoor EEV test closed
5. Put the unit in Charge mode heating for 5 minutes.

Once all the steps are complete put the system back in normal operations.

If the system controller (HUB) is not on 8.01 please make sure to update the software before moving forward with these steps.
