# Tech Tip

## February 2026

### ERR 203.00 Technician initiated mitigation

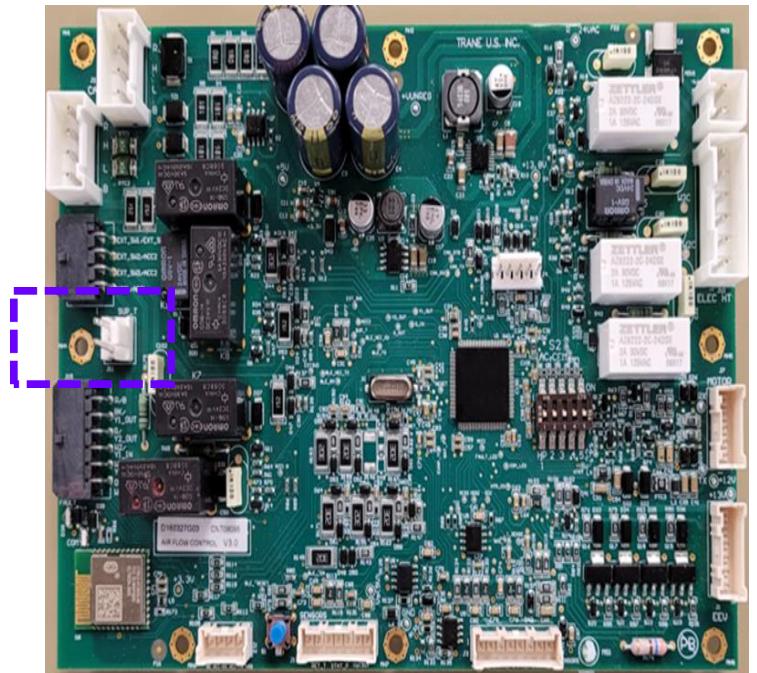
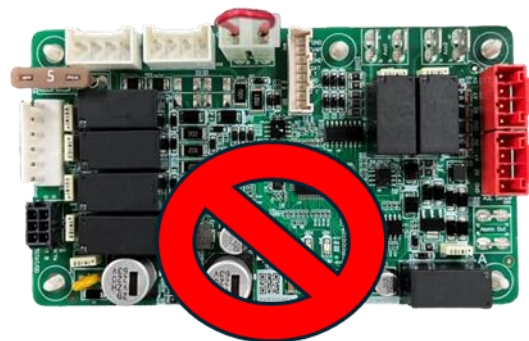
Link systems using 5STEMC ahu will produce error code 203.00 technician initiated mitigation when the supply air temperature sensor is plugged into the test pins on the mitigation board.

This is occurring because the ohms resistance is low enough to simulate that the test pins have been shorted together.

The supply temp sensor should be plugged into the AHC board on J11 which is the larger of the 2 boards.
