# Tech Tip

## October 2023

## TAMX- Sensor Wire Color Changes

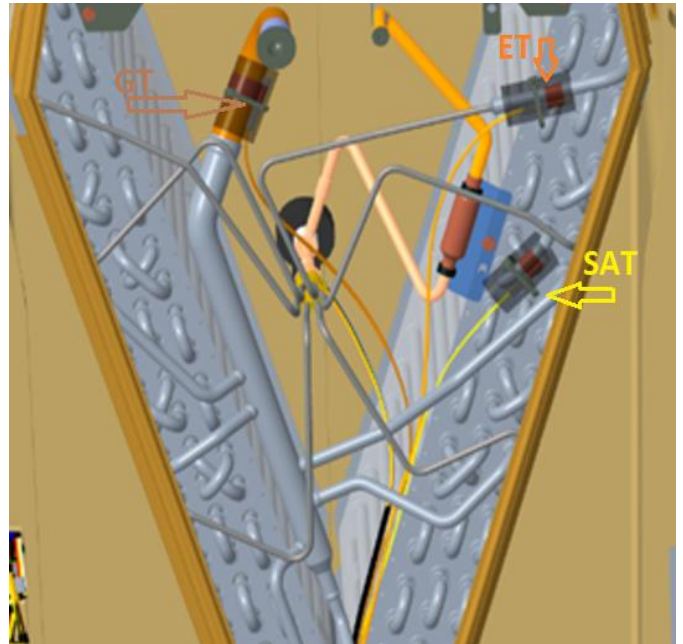
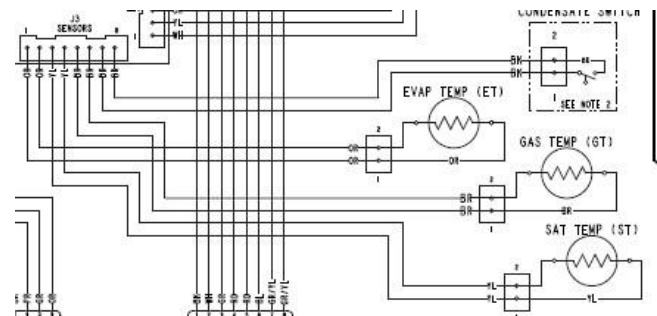
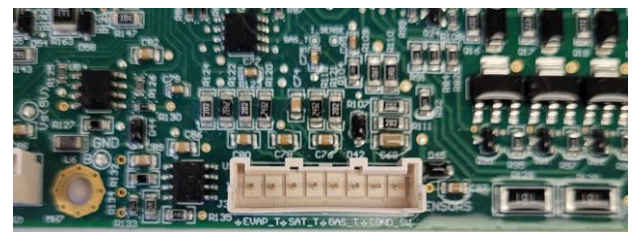
The Gas Temp (GT) sensor is no longer black but now **brown**.

The Evap Temp (ET/Coil) sensor has gone from yellow to **orange**.

And a new Saturation (SAT) sensor is **yellow**. *Bonus tip: This sensor does nothing currently and does not affect the operational logic of the EEV process. If it fails however, an alert will be generated.*

This can cause some confusion as we're accustomed to yellow being the ET/Coil sensor. We have had some reports of the ET and SAT sensors getting reversed. Think about what that would do. With the ET sensor at the warmer SAT location, the EVC would see lower superheat and command the EEV to a smaller position, attempting to build superheat. You would then see a lower suction pressure and a higher superheat.

A great troubleshooting tool is the Link Diagnostic phone app where you can compare what the EVC is reporting, compared to what you observe with gauges and temperature probes.
