Tech Tip

XV17 Not showing in Equipment Summary

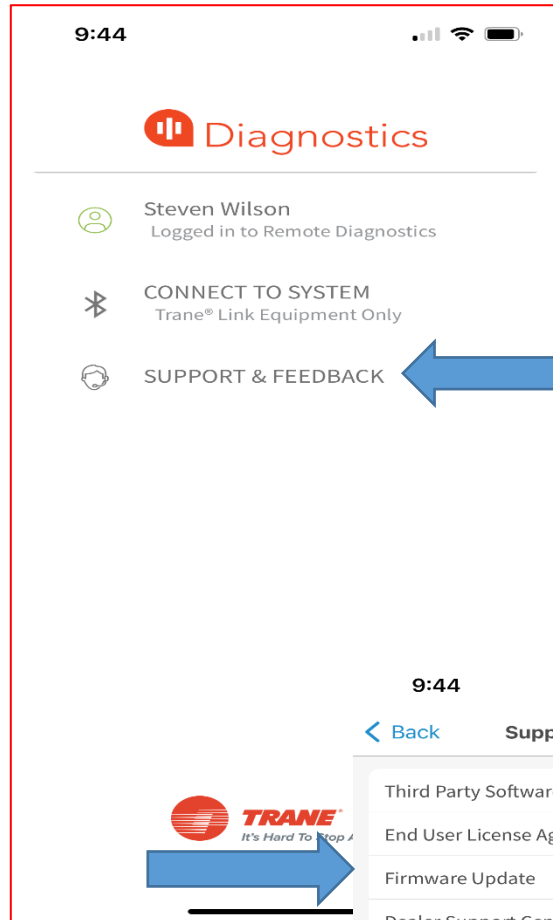
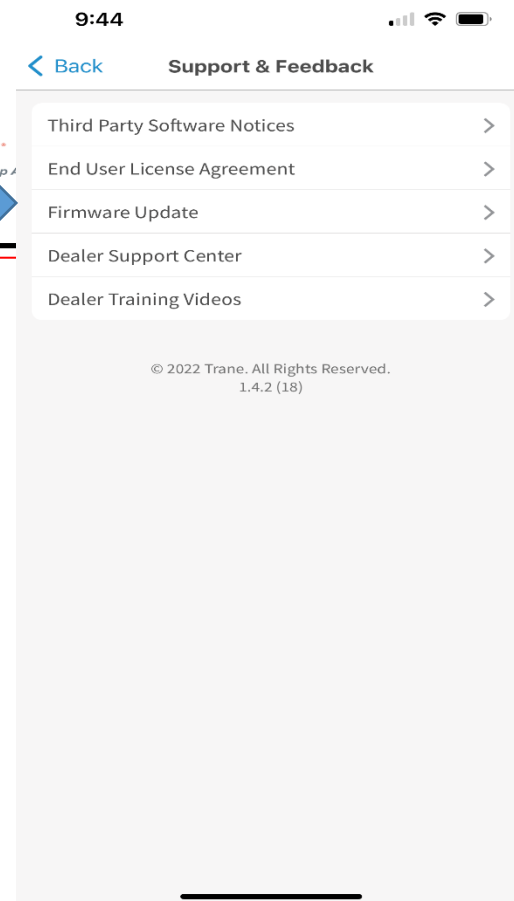
Follow the steps on the next page on how to push the software VIA SOFTAP,

We have found it is easier to push the software from the diagnostic mobile app via SoftAp to the hub.

Please remember that after the software is pushed it will take up to 3 hours before it will reach each device.

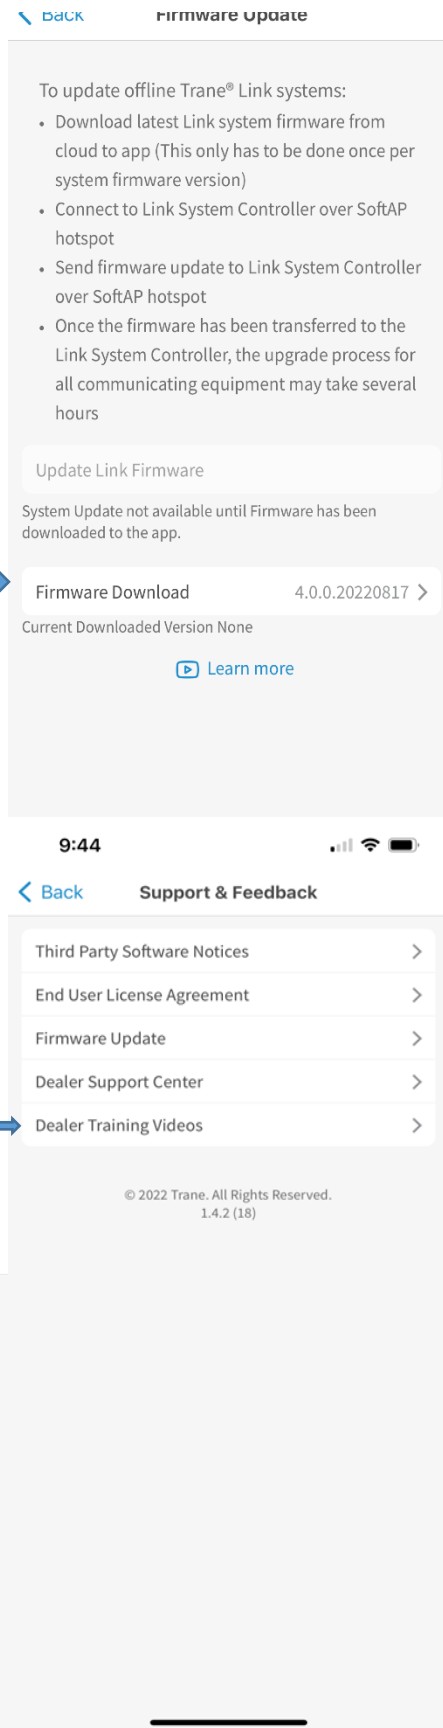
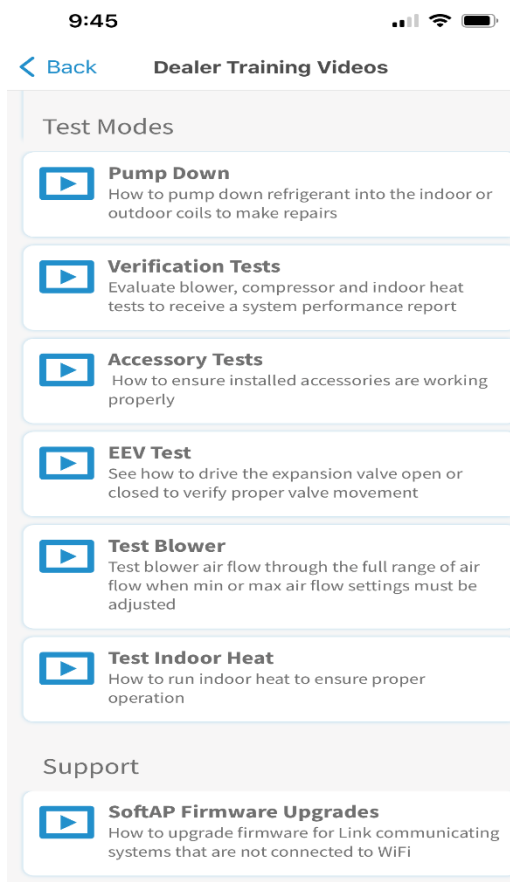
Software update for Link

The next screen will pop up in the top right that will show the latest firm ware and you will need to click on it to down load it to your phone, this process should only take a few minutes.

I suggest to watch the video link in the support and feedback page as shown to the right, when you scroll down just click on the Firmware upgrades and it will take you through a step by step process of updating the firmware through the app.
