# Tech Tip

September 2023

# Odyssey Symbio MODbus communication troubleshooting

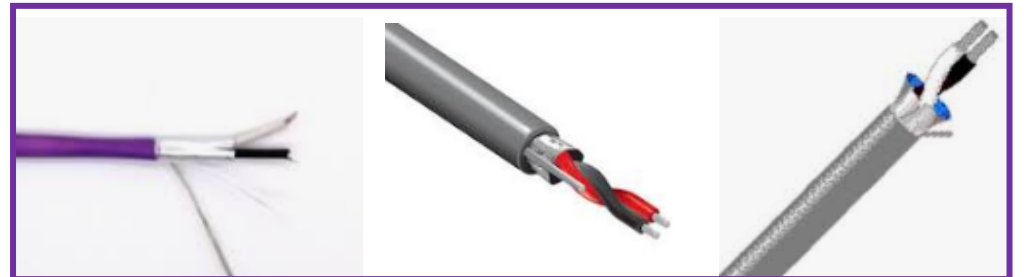
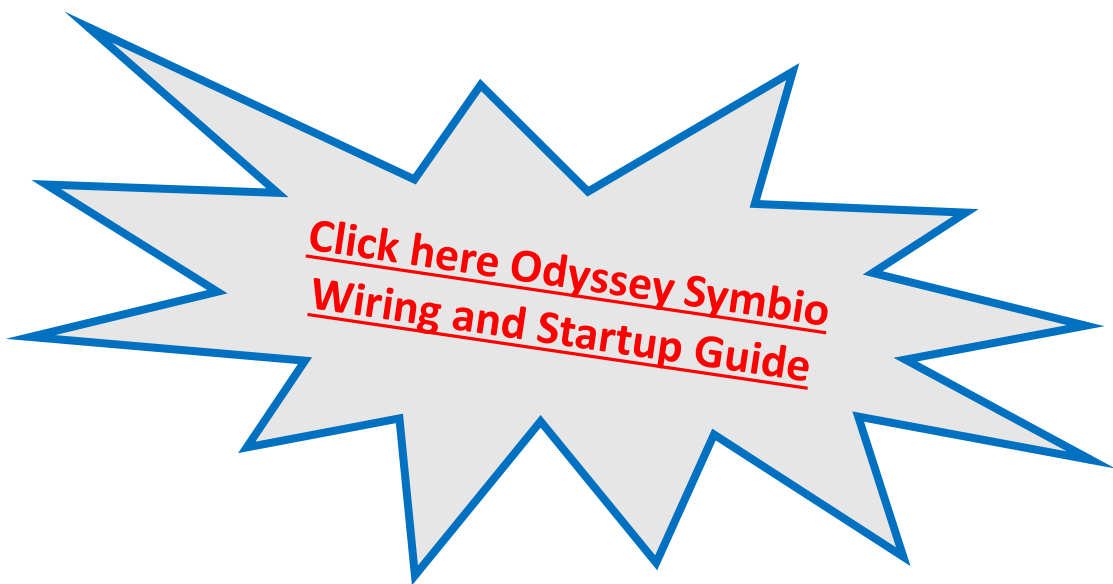
TTA / TWA - Cooling / Heat Pump Condenser with Symbio
Digit 15 – Controls
<b>S = Symbio™</b>

TWE Air Handler with Symbio
Digit 15 – Controls
1 = Constant Volume
C = 2 Stage Airflow (Electromechanical Condenser Only)
<b>D = 2 Stage Airflow/Single Zone VAV (Symbio Condenser Only)</b>

D = VFD - Modbus Communication  
2 twisted / shielded pair 18 awg

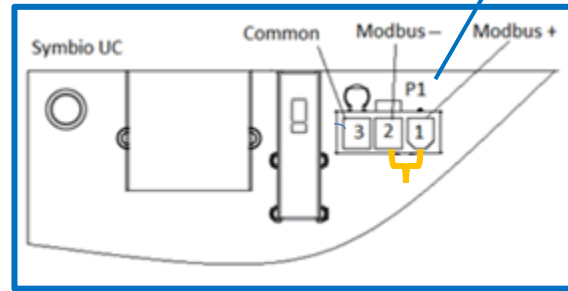
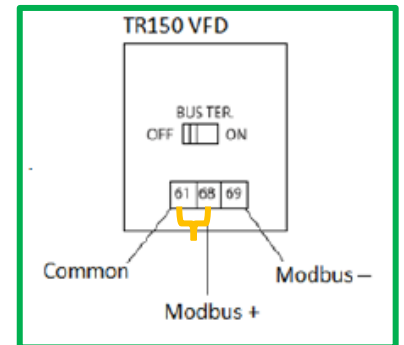
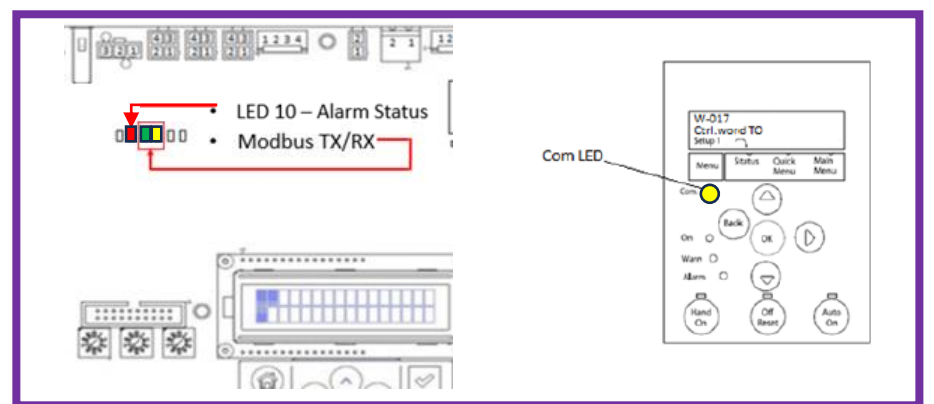
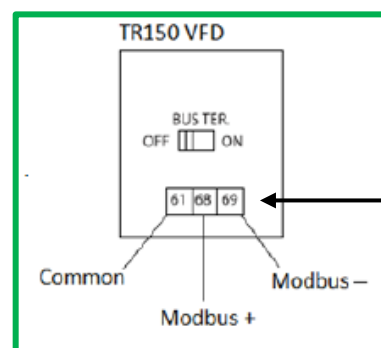
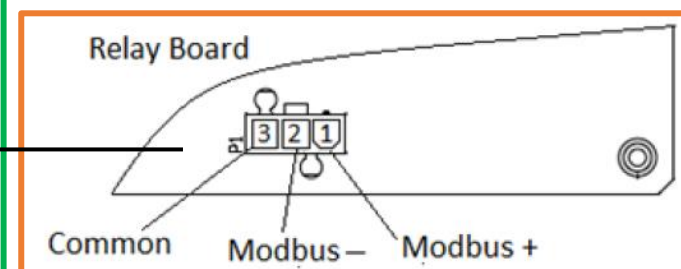
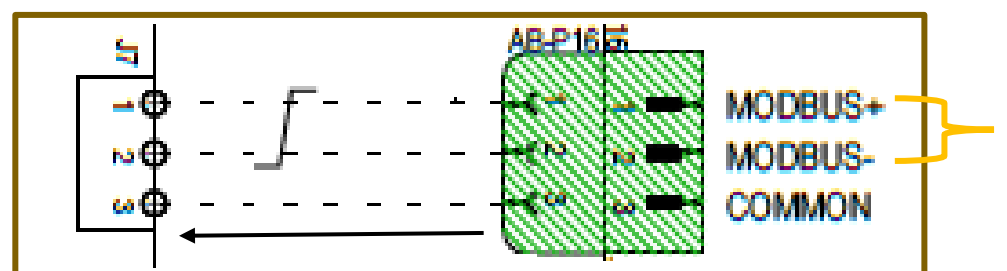
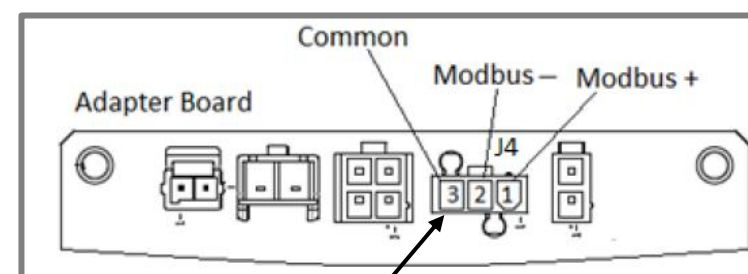
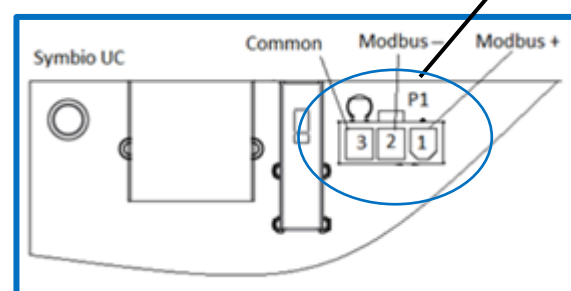
Modbus communication originates from the Symbio 700 Board at P1.

Normal Modbus Com between Symbio board and ID TR150 VFD is 4.73 to 4.15 VDC pulsing approximately 10 times a minute, no pattern.

If communication is normal; At Symbio board Modbus LEDs TX/RX will pulse at the same time with about a second in between and a couple quick pulses every now and then. The Com LED on the VFD keypad will fast and slow flash.

If you do not have normal Modbus comm, you will get a red LED flashing at Symbio board. Also have multiple alarms that will show in the Symbio app at

“Supply Fan VFD communication status”. The Com LED on the VFD keypad will be solid ON or OFF.

The end of Modbus Com is the TR150 VFD. From there it goes to P1 at ID unit Relay board. The next connection point is at J7 Relay board terminal plug where the field connection of Com wire terminate at ID unit. The next point is the OD unit field connection of Com wire at J16 Adapter board terminal plug. At the OD unit Adapter board J4 plug then goes to where Modbus originates which is P1 of the Symbio 700.

When troubleshooting Modbus, use the LEDs. For direction. At the OD unit disconnect J16 field connection terminal plug and see if you are getting 4.73 to 4.15 VDC output from Adapter board. Then work your way to the furthest point to see when the communication voltage is not normal.
